Kilkenny Northern Ring Road Extension – (Freshford Road to Castlecomer Road)

Environmental Impact Statement Volume 4: Appendices

Client: Kilkenny County Council

Date: 6th December 2013

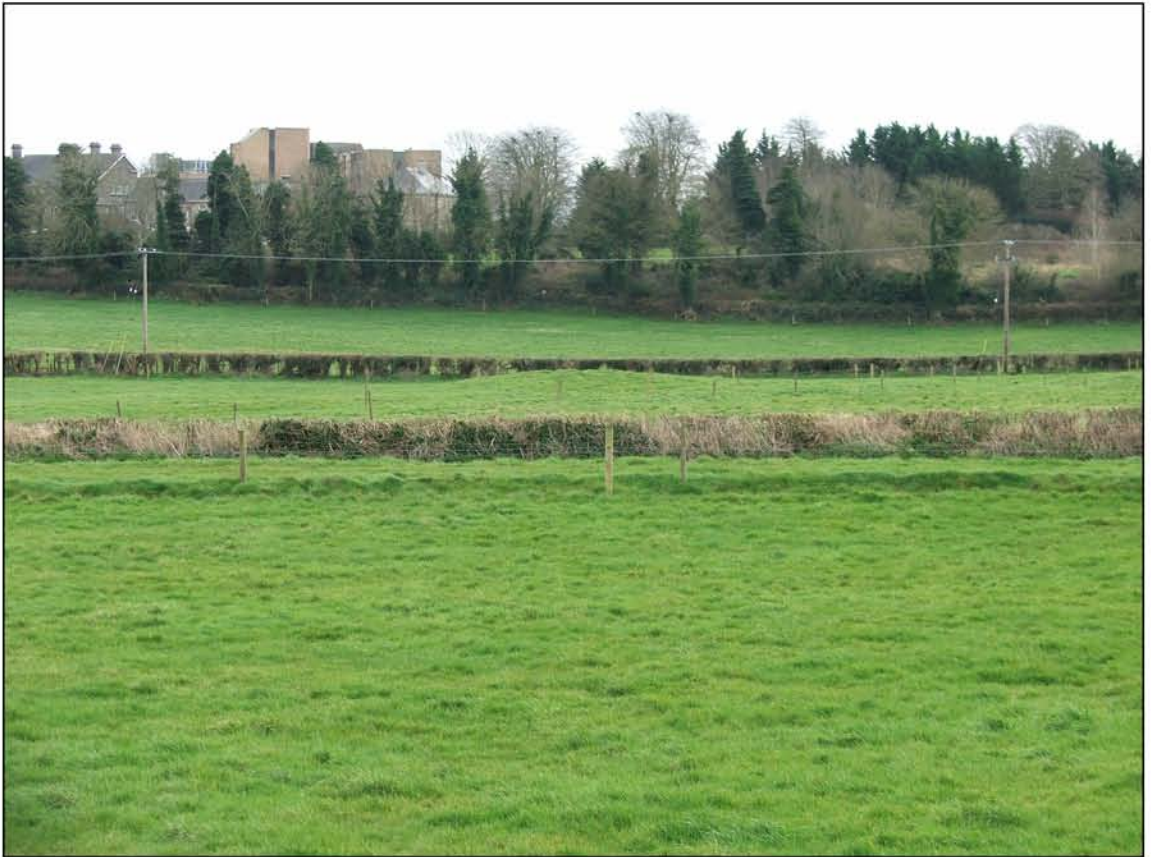
Plate 9 View of mound in field 5 from northwest

Field 5 is a very large pasture field bounded by the R693 road to the west, the stream to the south and the laneway to the north (Plate 10). It is subdivided by electric fencing and a slightly raised grassed path running north/south. The field is slightly undulating but otherwise relatively level pasture. A mound was identified in the approximate location of

a lime kiln marked on the first edition OS map (Plate 9), on the east side of the present electric fence that subdivides the field.

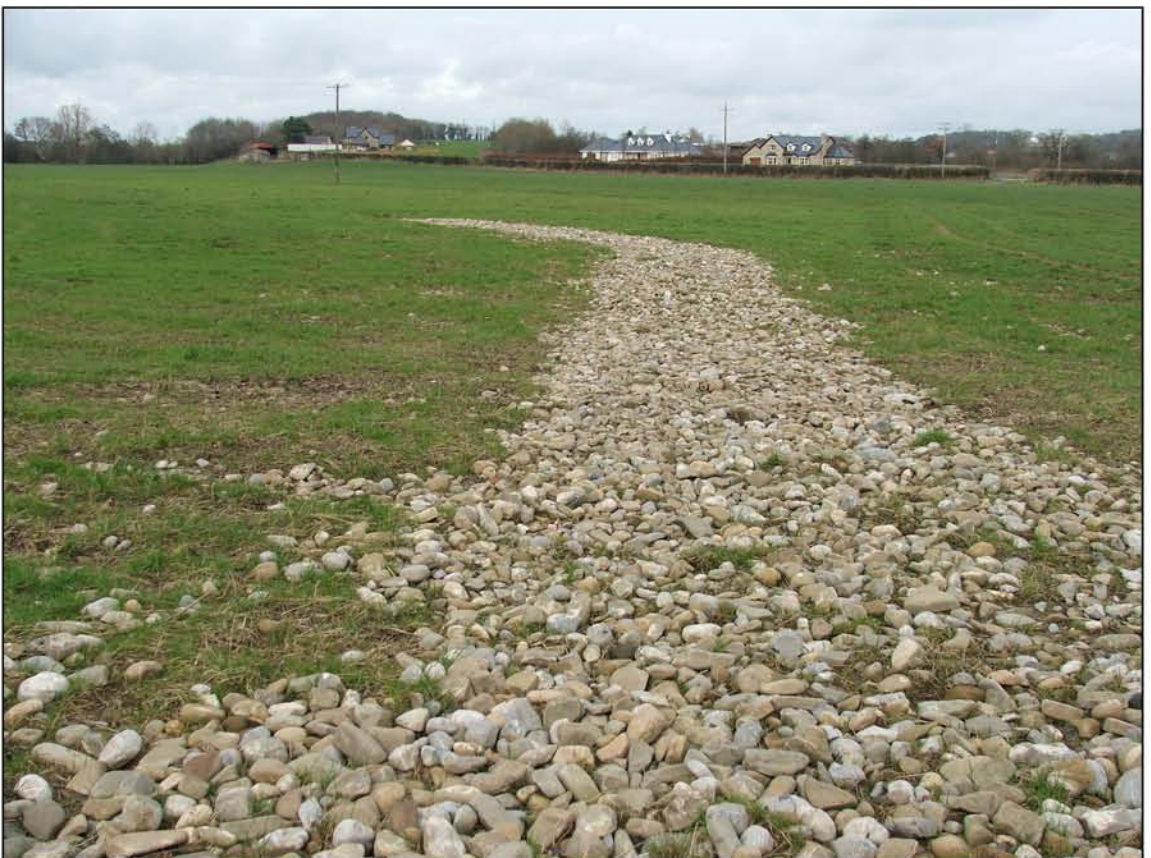
Plate 12 Field 9 facing north, showing gravel laid over pipe trench

Fields 8 and 9 are bounded by the River Nore to the west and a local road to the east (Figure 5). The river is approximately 10m wide and relatively fast moving, with water levels almost to the top of the banks at the time of the inspection. Both are level and under pasture, lying within the floodplain of the river. The river banks are lined with mature trees of varying size, but are otherwise clear of vegetation overgrowth. The ground is slightly waterlogged in places but otherwise appears well drained. A stream flowing into the river acts as a boundary between the two fields, with the smaller field 8 to the south. There was no surface trace of a circular feature identified on aerial photography at the south end of field 8 close to the river bank. All of the original field boundaries in field 9 have been removed to create a very large field occupying most of the land between the river and the road. A pipe has been laid through the field from the river, probably to service farm buildings immediately north of the assessment area in field 9 (Plate 12).

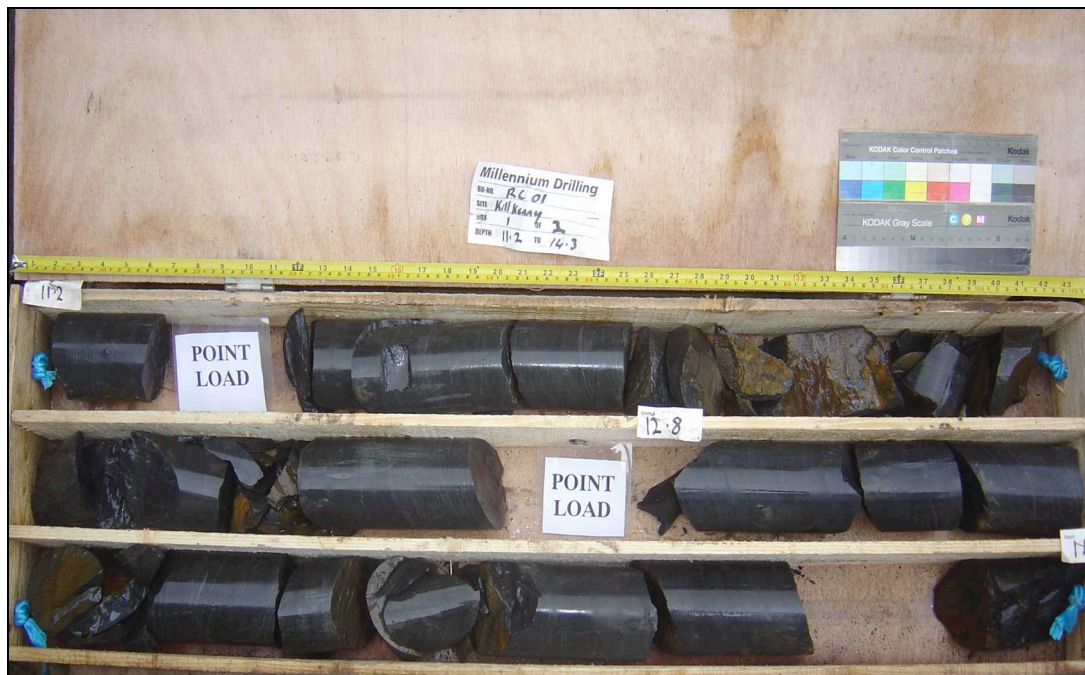
Figure 1 – Rock Core Quality (RC 1)

Rockhead depths range from approximately 11.2 to 14.1m and summary details are presented in Table 4. Weathering grades are typically fresh to slightly weathered and overall, rock quality is classed as good. RQD values are highly variable, with values ranging from 21 to 73%. Discontinuities are typically smooth and undulose to locally planar, while apertures appear to be 1 to 2mm. Dips are typically sub-horizontal to 30 / 40° and surfaces show localised iron staining or discolouration.

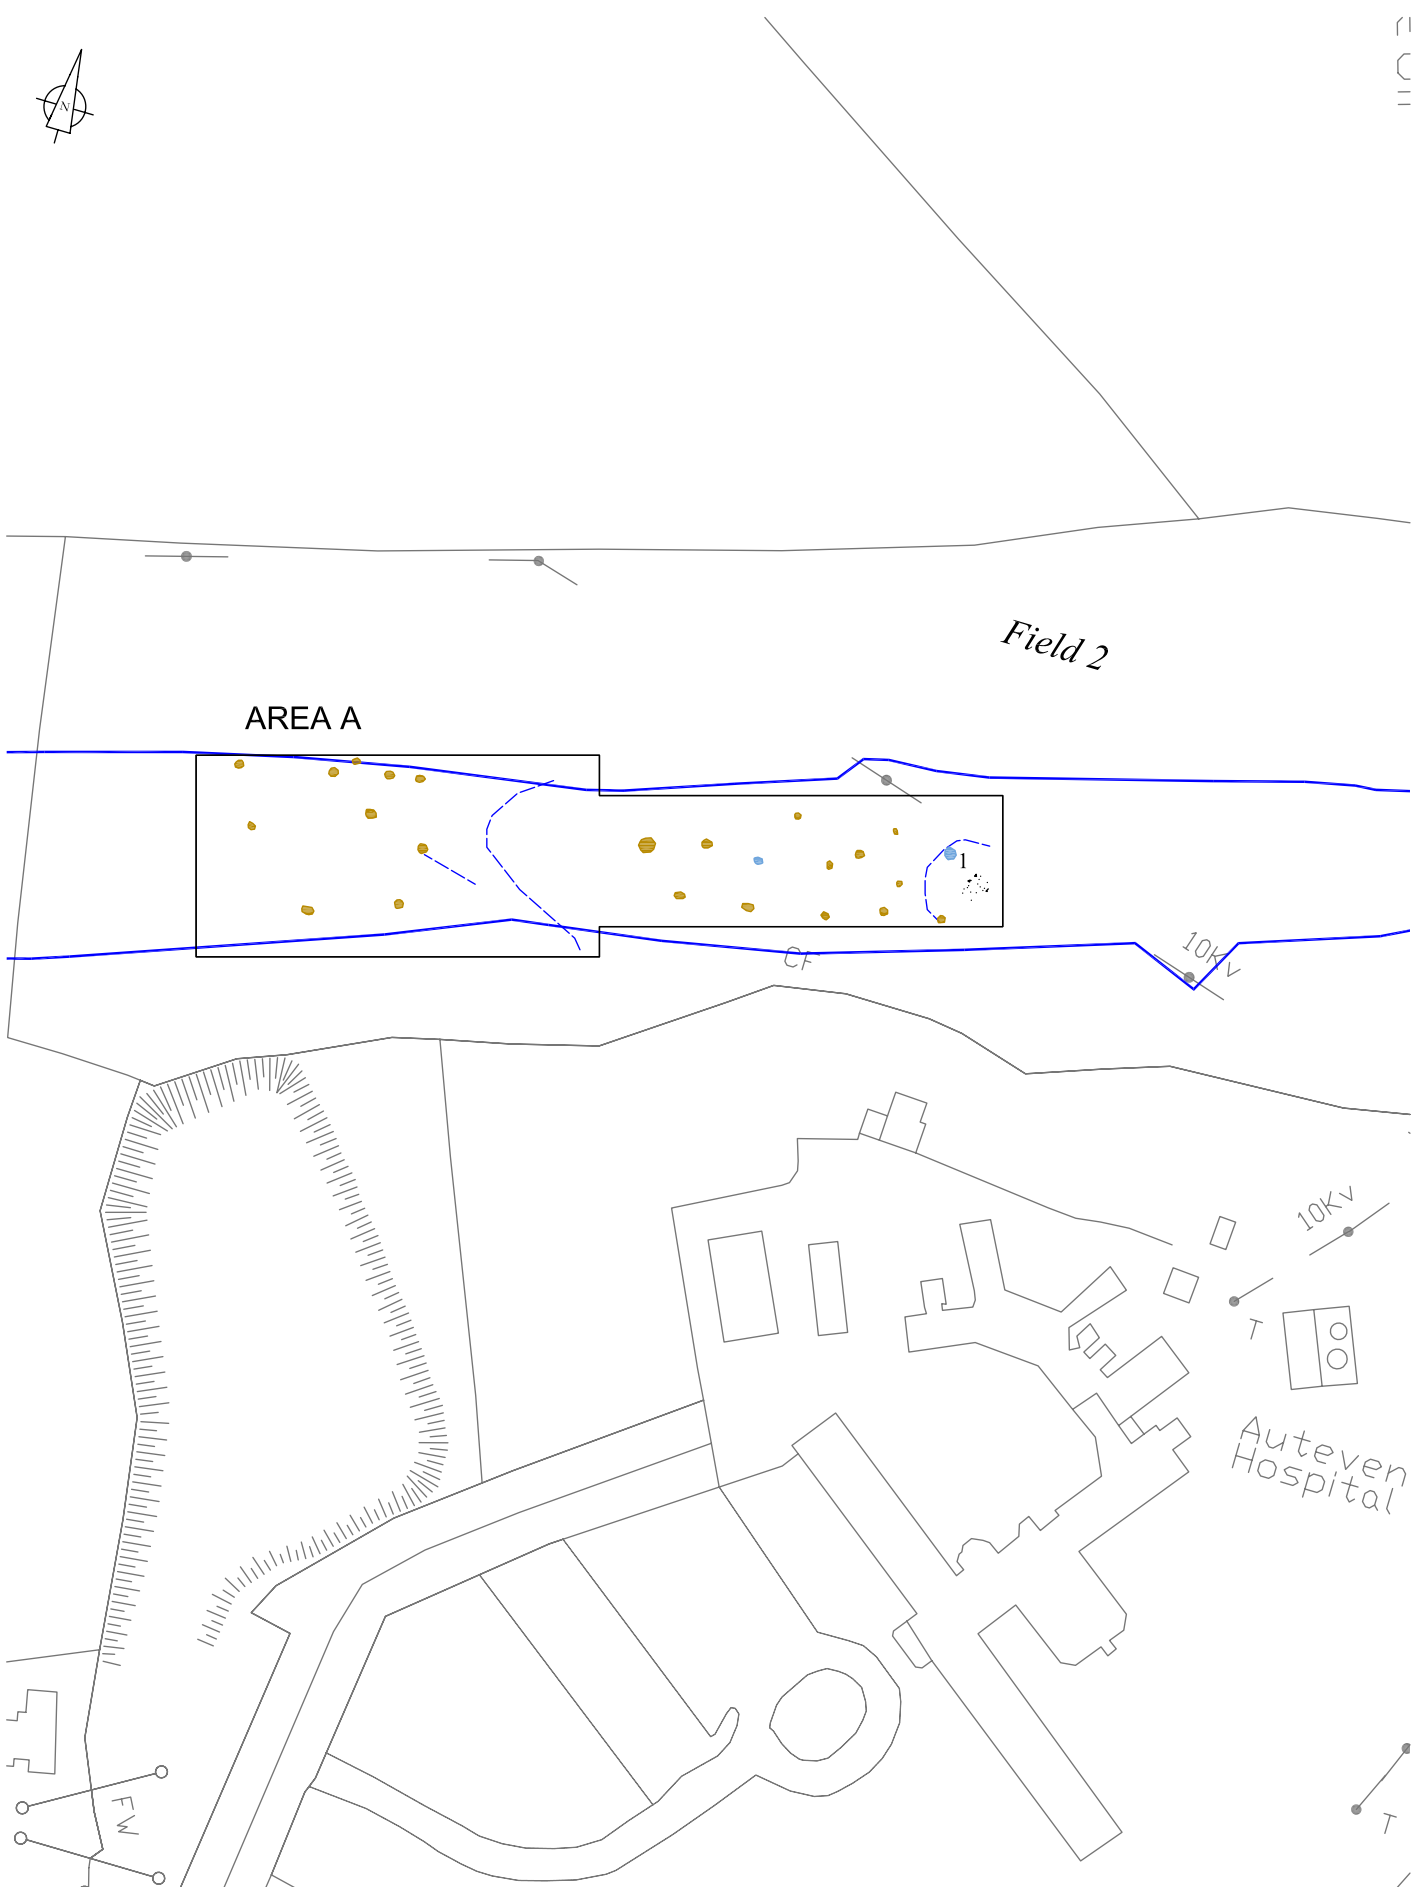
Scale @ A4: 1:1,500
Figure: 3
Licence No.: 13-R-41
Issue Date: 30.04.2013

- 3.1 Summary diagrams (Figures 3 to 6) present the results of detailed survey in Areas A, B and C. The summary diagrams display greyscale images of the data with and accompanying interpretation drawings. All the summary diagrams are displayed at a scale of 1:1,500.
- 3.2 Numbers in parentheses in the text of the report refer to specific responses highlighted in the detailed gradiometer survey interpretation diagrams.
- 3.3 The raw gradiometer data is displayed as a series of archive diagrams in Figures 7 to 9 and present the data as a series of xy-trace plots, greyscale images and interpretation drawings, all at a scale of 1:625.
- 3.4 The display formats referred to above, and the interpretation categories are discussed in the summary technical information section at the end of this report.
